Certificate of Test - Coating Adhesion

Trial Maintenance Coating System

CLIENT:	Dulux Protective Coatings Locked Bag 707 Milperra NSW 1891	PHONE:	(02) 9794 9423
CONTACT:	Ian Clark	FAX:	(02) 9794 9862
REPORT NO.	C10962	CTI JOB:	2519
TESTING OFFICER:	Fred Salome	REPORT DATE:	19 th April, 2010

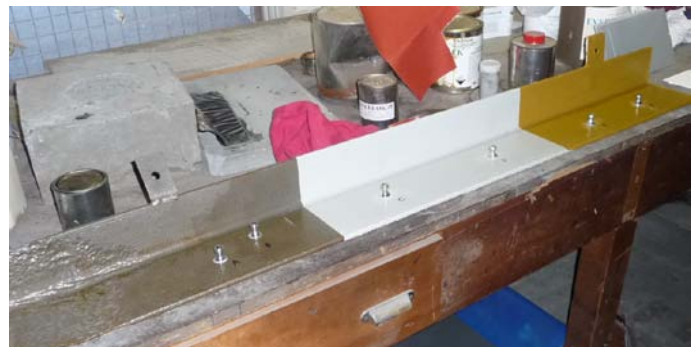
All coatings had been brush applied, and brush marks were clearly visible in the Durebild STE and the Weathermax HBR systems.

Failure in each case occurred at the glue/coating interface, attributed to the uneven surface of the coatings being tested.
